## Real Life Accident: First Mate Falls Into Cargo Hold While Operating Hatch Crane

While closing the hold a hatch fell out of the hatch crane and into the hold. This then caused the hatch crane to come off its rails on the starboard side. The first mate, who was operating the hatch crane alone from the operating platform, fell approximately eight metres into the hold; he was not wearing personal anti-fall protection (safety harness). He suffered serious injuries as a result of this fall and was admitted to hospital in a critical state.

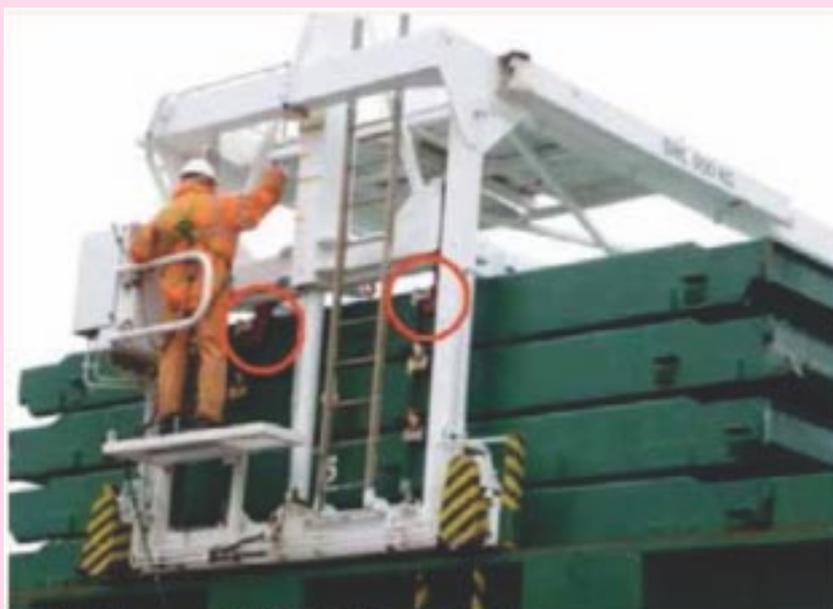
The hatch crane and hatch arrangement are similar to those in many small ocean going and inland vessels. The hatch crane rides on both sides of the hold over rails which are fitted to the hatchway coaming. The crane consists of two vertical uprights and a yoke, placed athwartships [across the width of

The hatch crane with hatch in hooked position

the vessel] and fitted with hooks from which the hatches are hung during hatch movement. The hatches are fitted with attachment points, referred to as 'pockets'. There are markings on both the hatches and the hatch crane to indicate the correct position of a hooked-up hatch relative to the hooks of the hatch crane. The person who operates the crane stands on the hatch crane, either on one side or on top, and rides along with the hatch crane while the hatch is moved.

Because the hatch was being transported in a high position, not only was its centre of gravity higher than need be, but also there was little chance of it

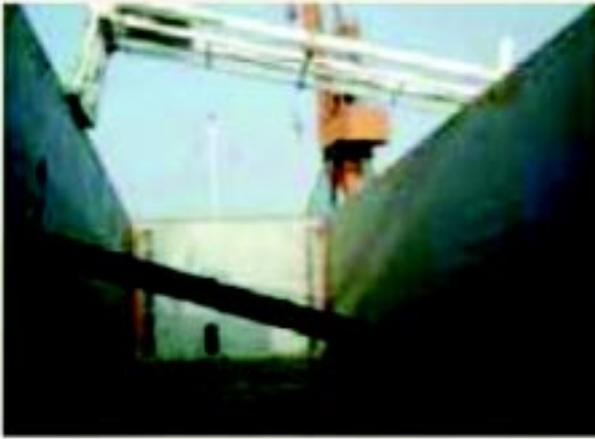
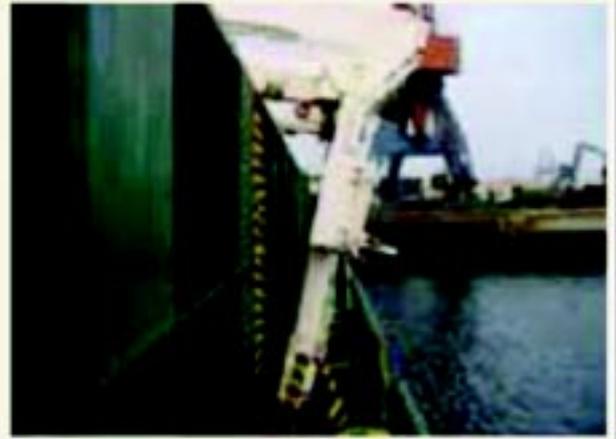
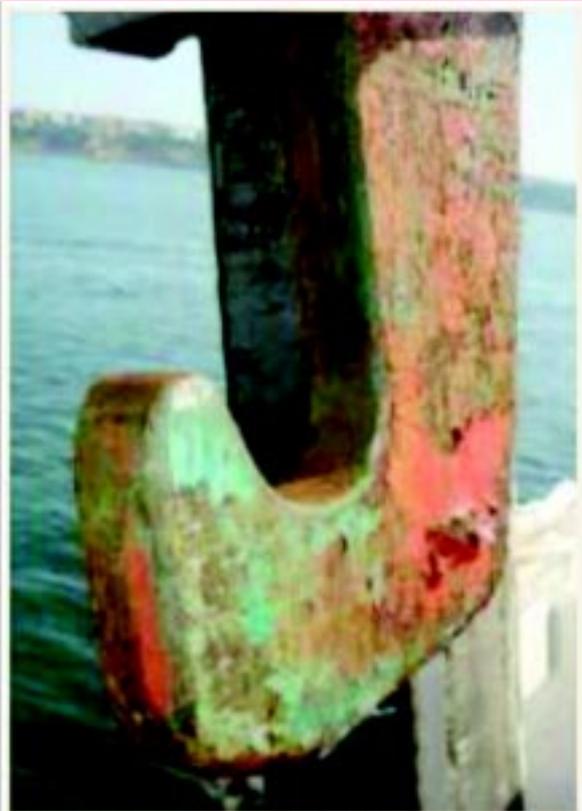
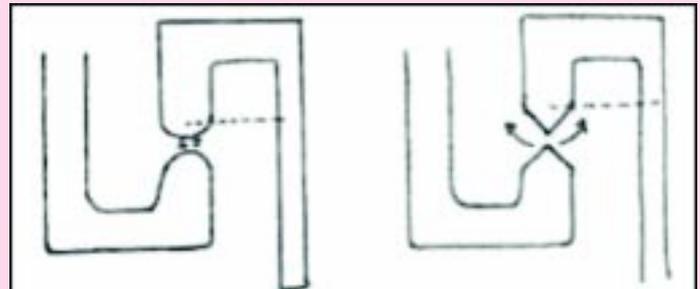
**Hooks used with blunt end**

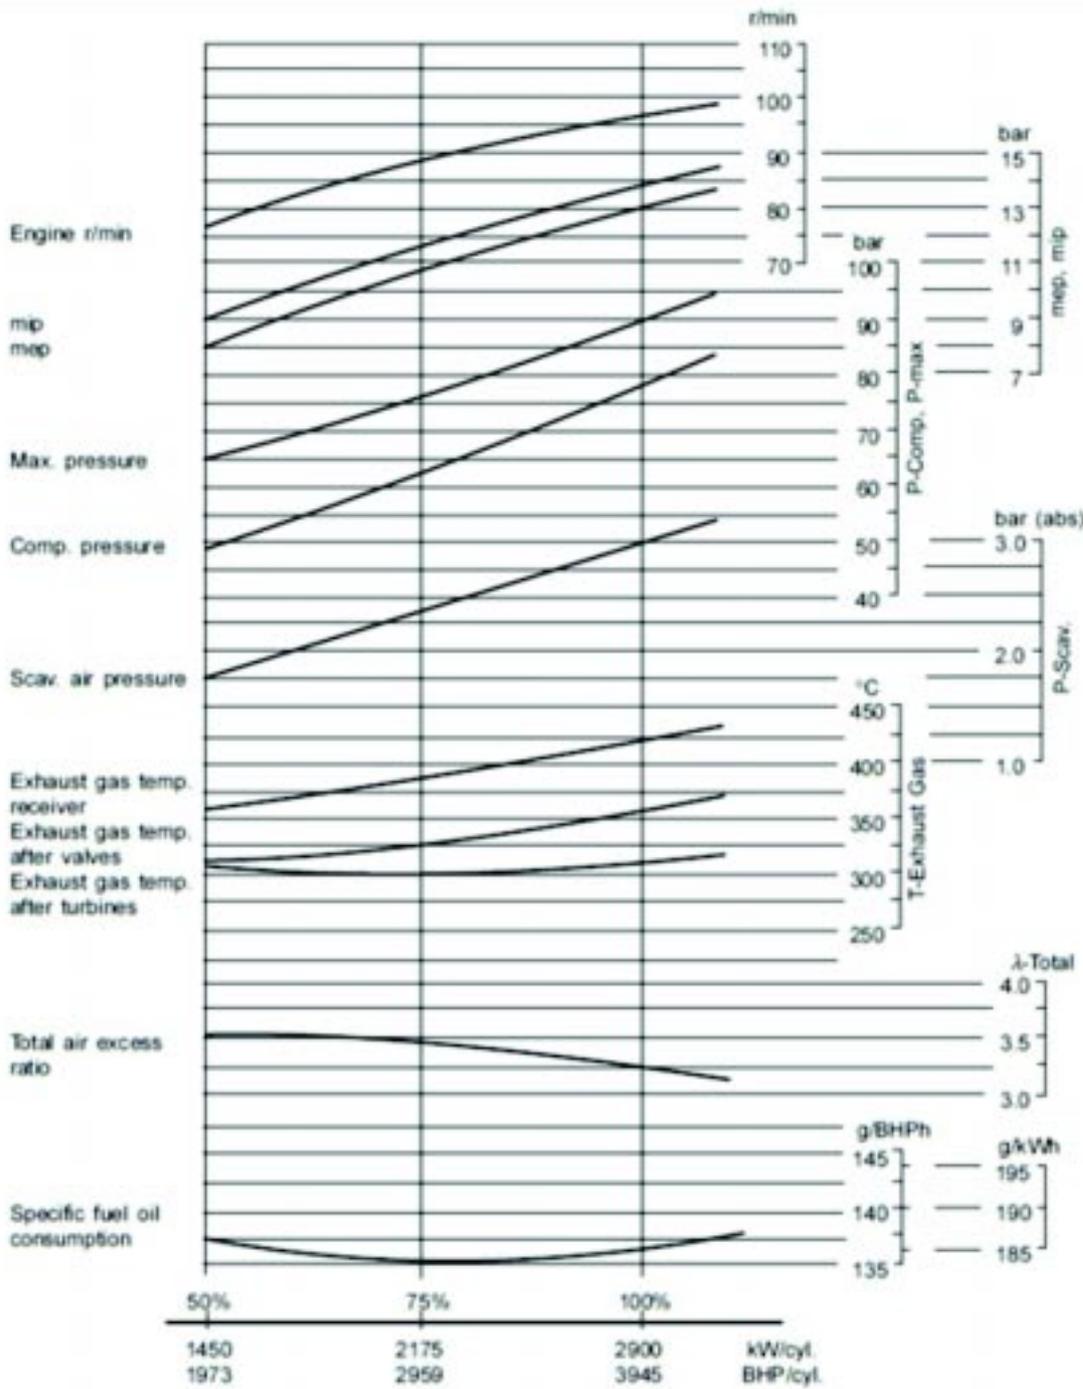
The main engine will run economically if the engine is well maintained and is run at the rated economic rating where the Specific Fuel Oil Consumption is the least. An engine is said to be performing well or well maintained if it can be safely run at the rated RPM at the rated load. For example if an engine is having a continuous service rating of 15000 BHP at 104 RPM but cannot reach the rated RPM and is developing 15000 BHP prematurely at 98 RPM, there is a loss of ship's speed and a subsequent speed claim. It also tells that there is a problem, the ship cannot give speed, it is

over consuming fuel and that the engine is over loaded. It points to either hull fouling, damaged propeller or faulty prime mover etc.

In such cases the careful study of the sea trial data, engine shop trial data and the performance curves will help to determine the cause of the problem.

For trouble shooting first the main engine performance must be taken on a good weather day when the engine load is steady. The main engine must be run to its rated power. Thereafter the data found must be super imposed on the performance curves.

The above example will help to understand the use of performance curves for a ship's engineer. After the main engine performance has been taken and plotted on the original performance curves from the sea trial data, the problem can be found out and SFOC restored to normal values. In this way at any stage during the life time of the ship, we can understand why she is not performing based on plotting her parameters on the performance curves.

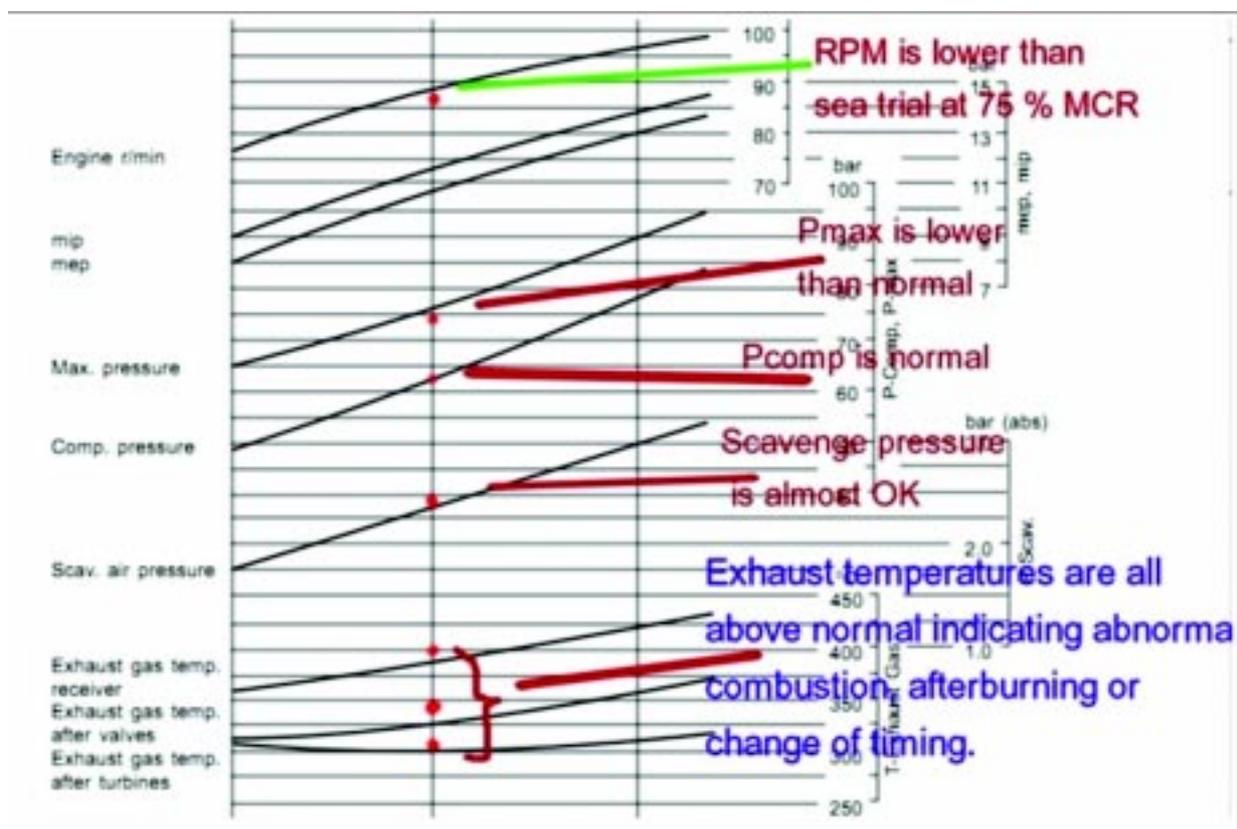
From above diagram the following points are inferred:

- " At 75% MCR the RPM attained is lower than the sea trial.
- " The average maximum cylinder pressure  $P_{max}$  is lower than the sea trial.
- " The compression pressure  $P_{comp}$  is almost same as sea trial confirming that the running gear like piston, piston rings and exhaust valves are ok.
- " The scavenging pressure is almost normal suggesting that the turbocharger is in satisfactory condition and the enthalpy of the exhaust gas is higher than normal for this RPM.
- " Exhaust temperatures are all increased suggesting abnormal combustion, after burning or change of timing. It may also indicate faulty fuel injection equipment.
